2-Wire Loading Issues

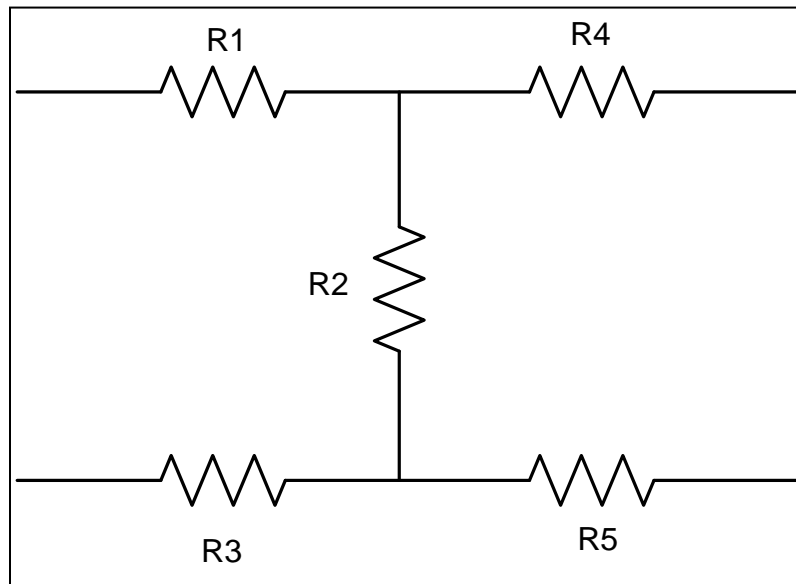
Below is a drawing and values for a 6 dB loss 600 ohm balanced H pad

R1 = 100 ohms
R2 = 820 ohms
R3 = 100 ohms
R4 = 100 ohms
R5 = 100 ohms

Adding an H-Pad can also help to achieve better loading and isolation. There is some loss involved but most customers report it is acceptable.
